**Flood Control Project Maintenance  
Levee Inspections**

**Fall 2018 Levee Maintenance Deficiency Summary Report**

**Flood Control Project Maintenance  
Levee Inspections****LMA District Cover Sheet****Fall 2018 Levee Inspection Results****Reclamation District No. 0817 Carlin**

**Reclamation District No. 0817 Carlin**

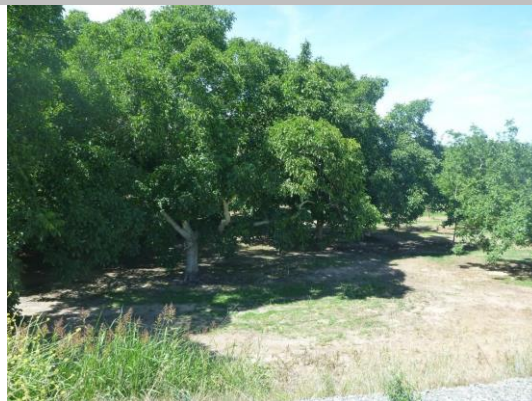
Photo 1 of 3 : LEVAL\_FA\_2018\_162\_287.jpg

LM Start	2.08	Rating **	A/W	Issue No.	13
LM End	3.18	Issue Type +	Ma	Location *	
Category	Supplemental			GPS Latitude/Longitude	
				Start	End
Item	2017 Storm Damage			38.989338 °	38.994124 °
				-121.468640 °	-121.449448 °
DWR ID	DWR_RD0817_02_f_2017_13				
Comment Code					
Inspector Comment					
Levee Evaluation Comments					
Description:					
Site ID No:162					
Site Designation:DWR_RD0817_02_s_2012_10					
Repair Type: Stability					
Rating:Area of Concern					
Field Date:6/5/2017					
Notes: Stability issues are due to levee geometry. Narrow steep slopes.

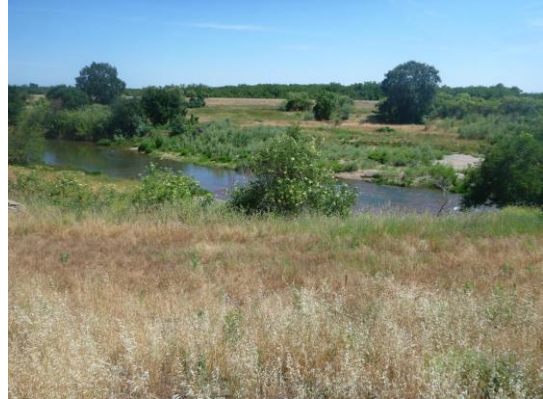
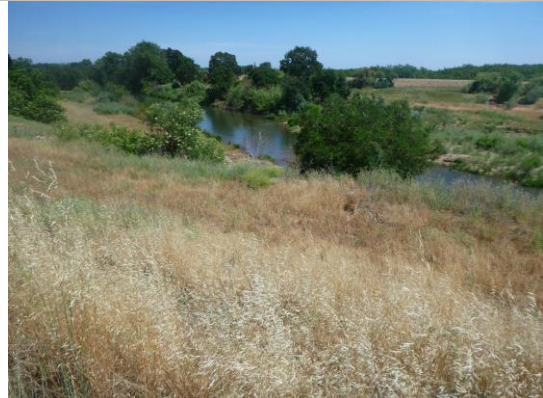
LM Start	2.08	Rating **	A/W	Issue No.	13 (cont)	
LM End	3.18	Issue Type +	Ma	Location *		
Category	Supplemental			GPS Latitude/Longitude		
				Start	End	
Item	2017 Storm Damage			38.989338 °	38.994124 °	
				-121.468640 °	-121.449448 °	
DWR ID	DWR_RD0817_02_f_2017_13					
Comment Code						
Inspector Comment						
Levee Evaluation Comments						
Description:						
Site ID No:162						
Site Designation:DWR_RD0817_02_s_2012_10						
Repair Type: Stability						
Rating:Area of Concern						
Field Date:6/5/2017						
Notes: Stability issues are due to levee geometry. Narrow steep slopes.

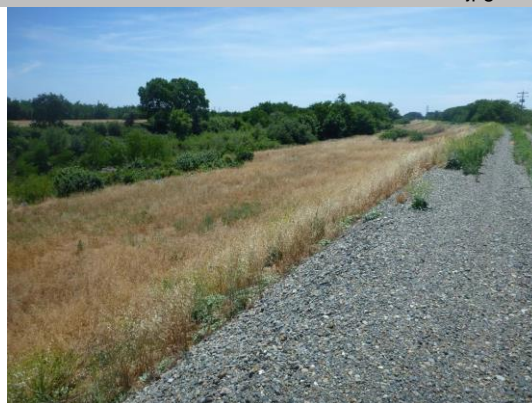
Photo 1 of 3 : LEVAL\_FA\_2018\_161\_1065.jpg

LM Start	2.72	Rating **	A/W	Issue No.	14
LM End	2.74	Issue Type +	Ma	Location *	
Category	Supplemental			GPS Latitude/Longitude	
				Start	End
Item	2017 Storm Damage			38.992170 °	38.992217 °
				-121.457332 °	-121.456967 °
DWR ID	DWR_RD0817_02_f_2017_14				
Comment Code					
Inspector Comment					
Levee Evaluation Comments					
Description:					
Site ID No:161					
Site Designation:240-3					
Repair Type: Erosion					
Rating:Area of Concern					
Field Date:6/5/2017					
Notes: No issue found. Narrow levee with steep slopes. Did not investigate bench due to rattlesnake concerns. Possible alternate location at 38.993282; -121.451562.

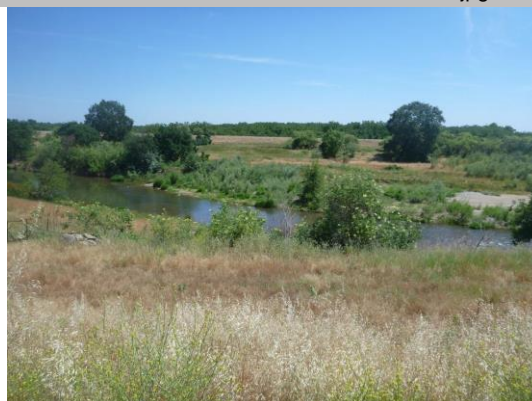
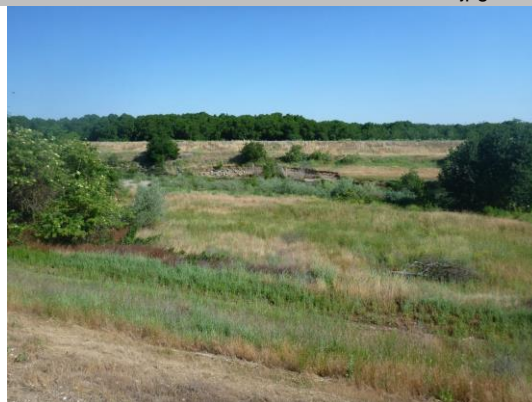
Notes: No issue found. Narrow levee with steep slopes. Did not investigate bench due to rattlesnake concerns. Possible alternate location at 38.993282; -121.451562.
